# The Dove Way: Landfill Redevelopment and Soil

# **Phase I: Site Characterisation**

The Dove Way Soil reclamation scheme comprises of a household waste recycling centre (HWRC) and access road on a historic municipal co-disposal landfill which is recorded to have operated between 1964 and 1978.

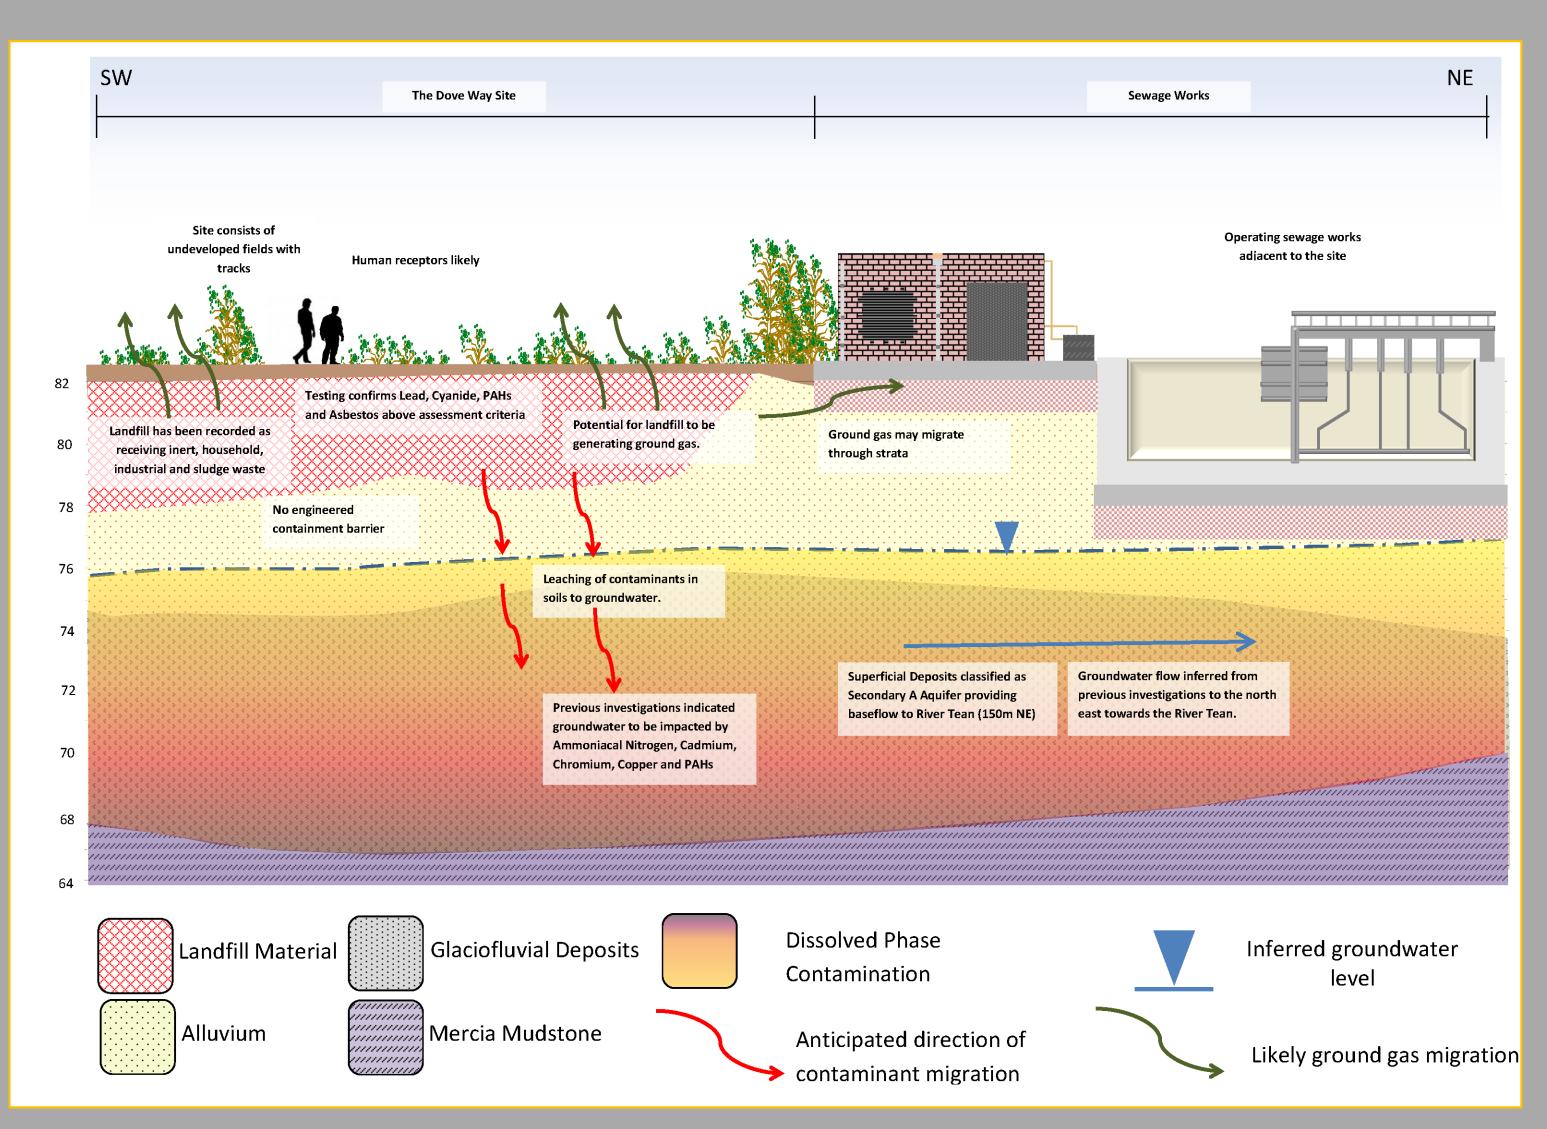
# Preliminary Conceptual Site Model

Artificial Ground	Made Ground / Landfill Material	•	Likely to be contaminative in nature Pose a risk to human health, controlled waters Potential ground gas generation	
Superficial Geology	Alluvium Glaciofluvial Deposits	•	"Secondary A Aquifer" providing baseflow to primary river 150m to the north	
Bedrock Geology	Mercia Mudstone	•	Naturally halite bearing strata, typically fractured, weak and friable	
Landfill and Was	te Sites			
Landfill adjoining Pennycroft Sewage Works (0m onsite)		•	Located on site Operated between 1964 and 1978. Waste deposited was a mixture of inert, industrial waste, commercial, household waste, and liquids/sludge	
Old Site The Wharf Historic Landfill (80m South)		•	Up hydraulic gradient of the site. Operational dates unknown but likely between 1981 and 1997 Within an area of a Gasworks shown to be present circa 1922 to 1937	
Surrounding Lan	d Use			
Uttoxeter Gasworks (135m South)		•	Present circa 1922 operative up until 1937 Infrastructure present up until 1997

Uttoxeter Sewage Works (0m East)		•	Present since 1922 Expansion of filter/sludge beds Remained operational to present day.

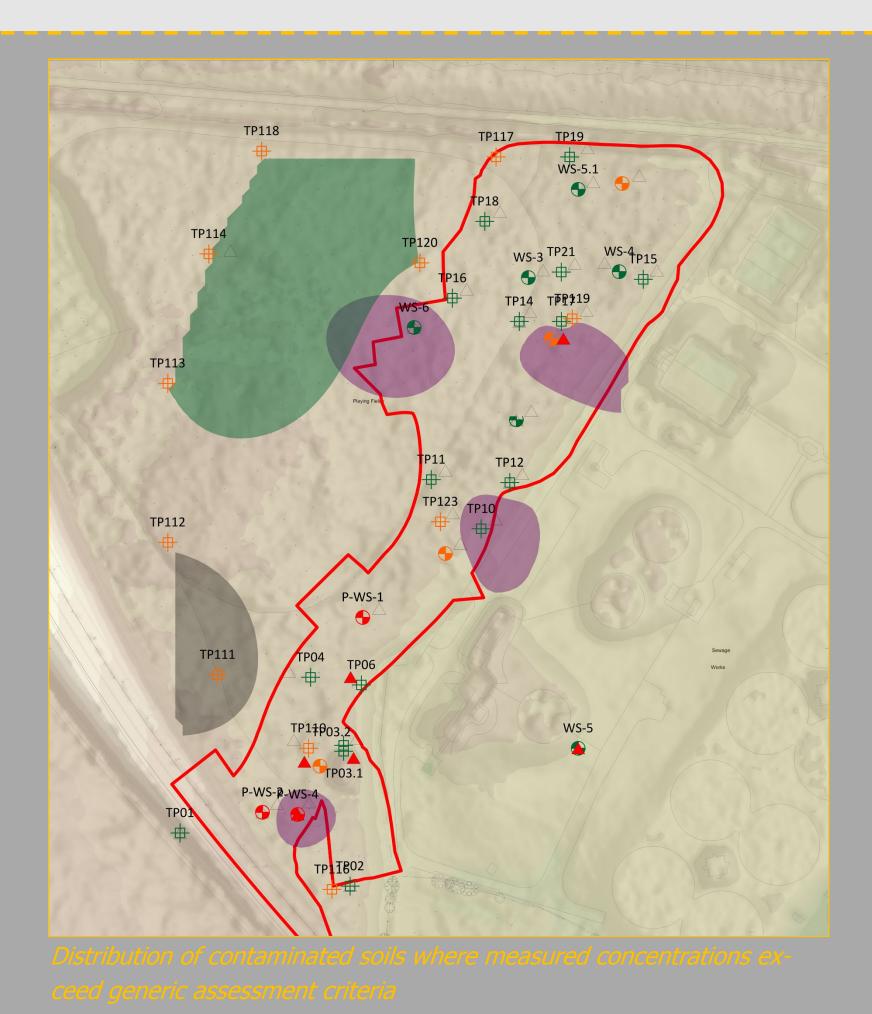
**Revised Conceptual Site Model**

The most at risk receptors are considered construction workers due to the nature of construction works and probable contact with contaminated soils. Risks were mitigated through suitable PPE and procedure. An asbestos specialist was present throughout works under CAR-SOIL 2012 (4) and CIRIA C733 (5) Asbestos guidance.

To mitigate exposure to site end users, a clean cover with anti-dig geotextile membrane was placed in all areas of soft landscaping to provide a cover to asbestos impacted soils. The hardstanding of the access road and HWRC also breaks any viable pathways to end users.

Monitoring indicated completion of  $CH_4$  generation. A residual  $CO_2$  production phase has been recorded likely to be a function of well effects introducing oxygen into the underlying alluvium.

The majority of the site is of a low sensitivity, the sole building, a mini cabin, was designed on raised supports to allow free flow of air beneath the structure to reduce the potential of gases to accumulate in hazardous concentrations.

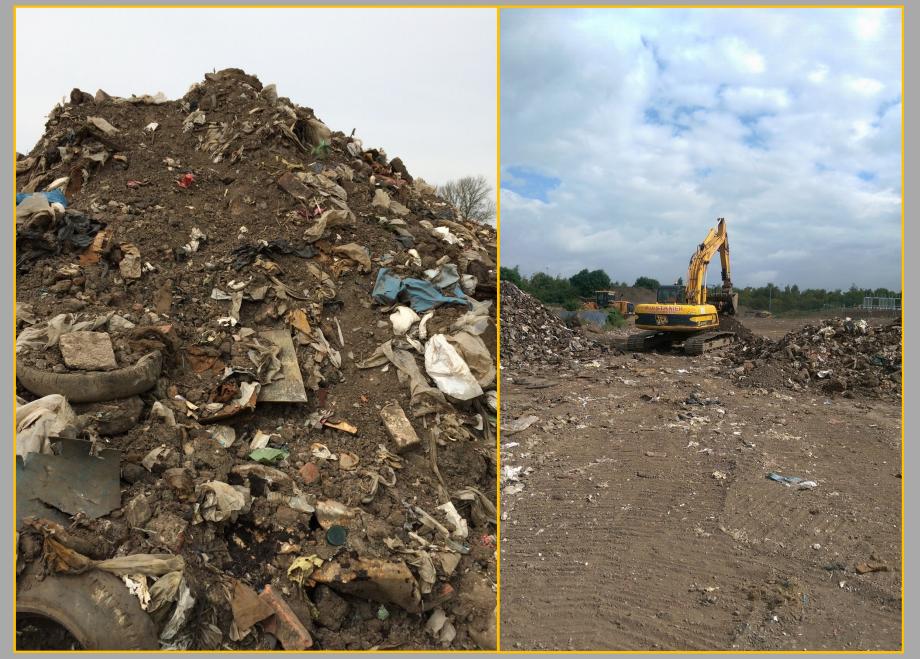
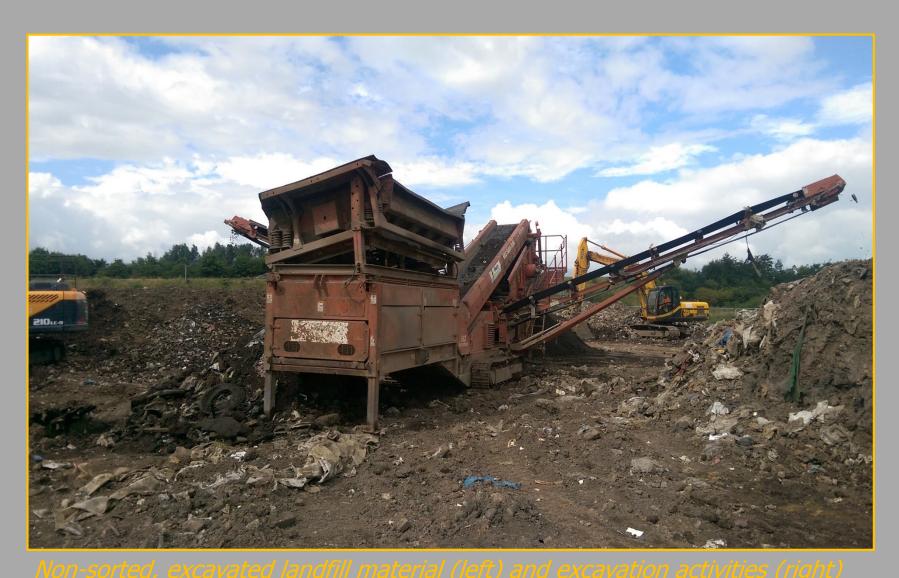
During construction works it was necessary to undertake excavations into the former landfill site, resulting in the generation of a significant quantity of mixed landfill wastes.

These comprised domestic refuse including tyres, glass, wood, paper and plastics as well as construction wastes, such as concrete and brick, mixed with soils that would have been used as daily cover during the landfill lifecycle.

Approximately 9700m<sup>3</sup> of material was excavated. Of that, 2500m<sup>3</sup> was site won topsoil ,and 7200m<sup>3</sup> site won landfill wastes including daily cover soil.

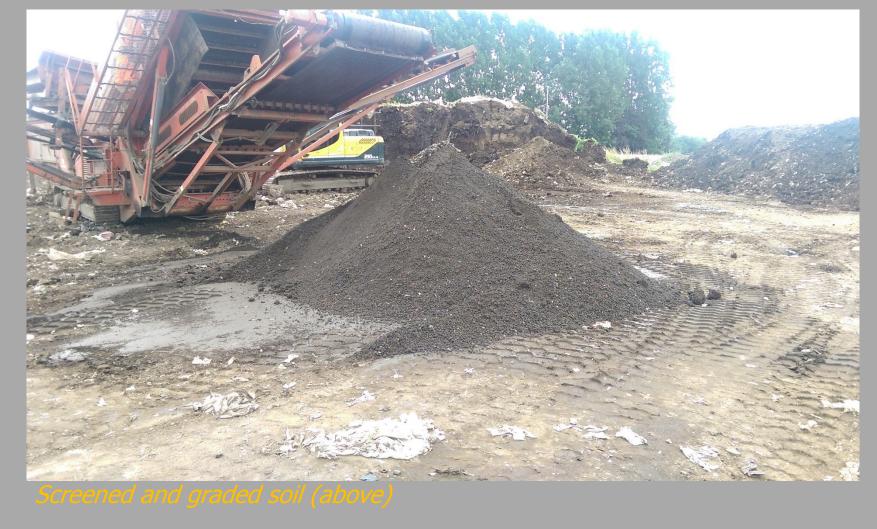
Screening was undertaken to separate three types of material grade; <25mm soil, 25mm-75mm aggregate and >100mm waste.

Asbestos specialists were present throughout the process of screening and aggregate crushing. Asbestos containing materials were identified, hand picked and removed for suitable disposal. Air quality monitoring was deployed to monitor for potential release of airborne fibres exceeding the occupational limit of 0.01f/ml.

The screened materials were processed at a minimum of two times to ensure maximum efficacy and recoverability in volumes of waste. Oversized aggregate was processed onsite by rock crushing.

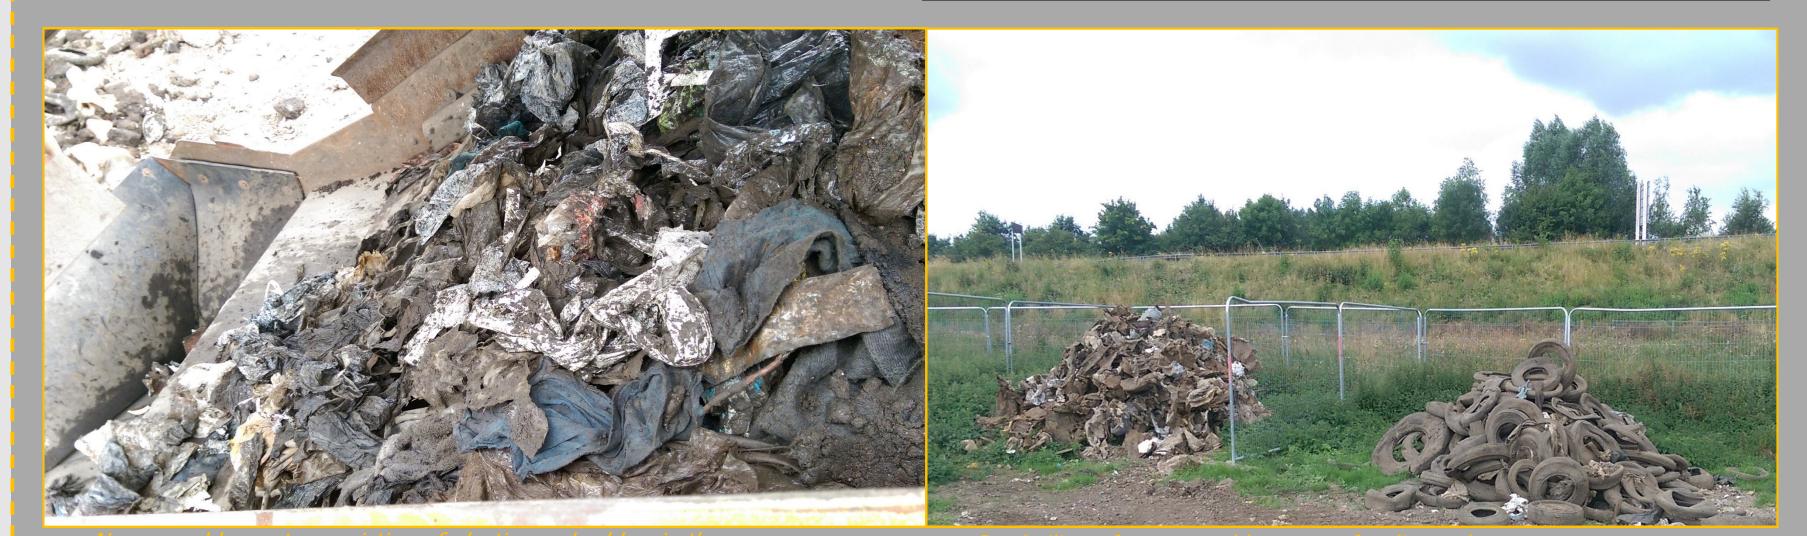
Materials, accounting for 2750m<sup>3</sup>, which did not pass through the screening process were disposed of separately as waste and have not been re-used. As such they were stockpiled and disposed of offsite with the List of Waste codes (right).

Hatehar description		
Asbestos 70.1% concentration	17 06 05* – Construction materials	
within cement	containing asbestos	
Asbestos 70.1% concentration	17 06 01* – Insulation materials	
within lagging	containing asbestos	
within lagging Mixed Non-hazardous metals,	containing asbestos 19 12 04 - Plastic and Rubber	
	<b>U</b>

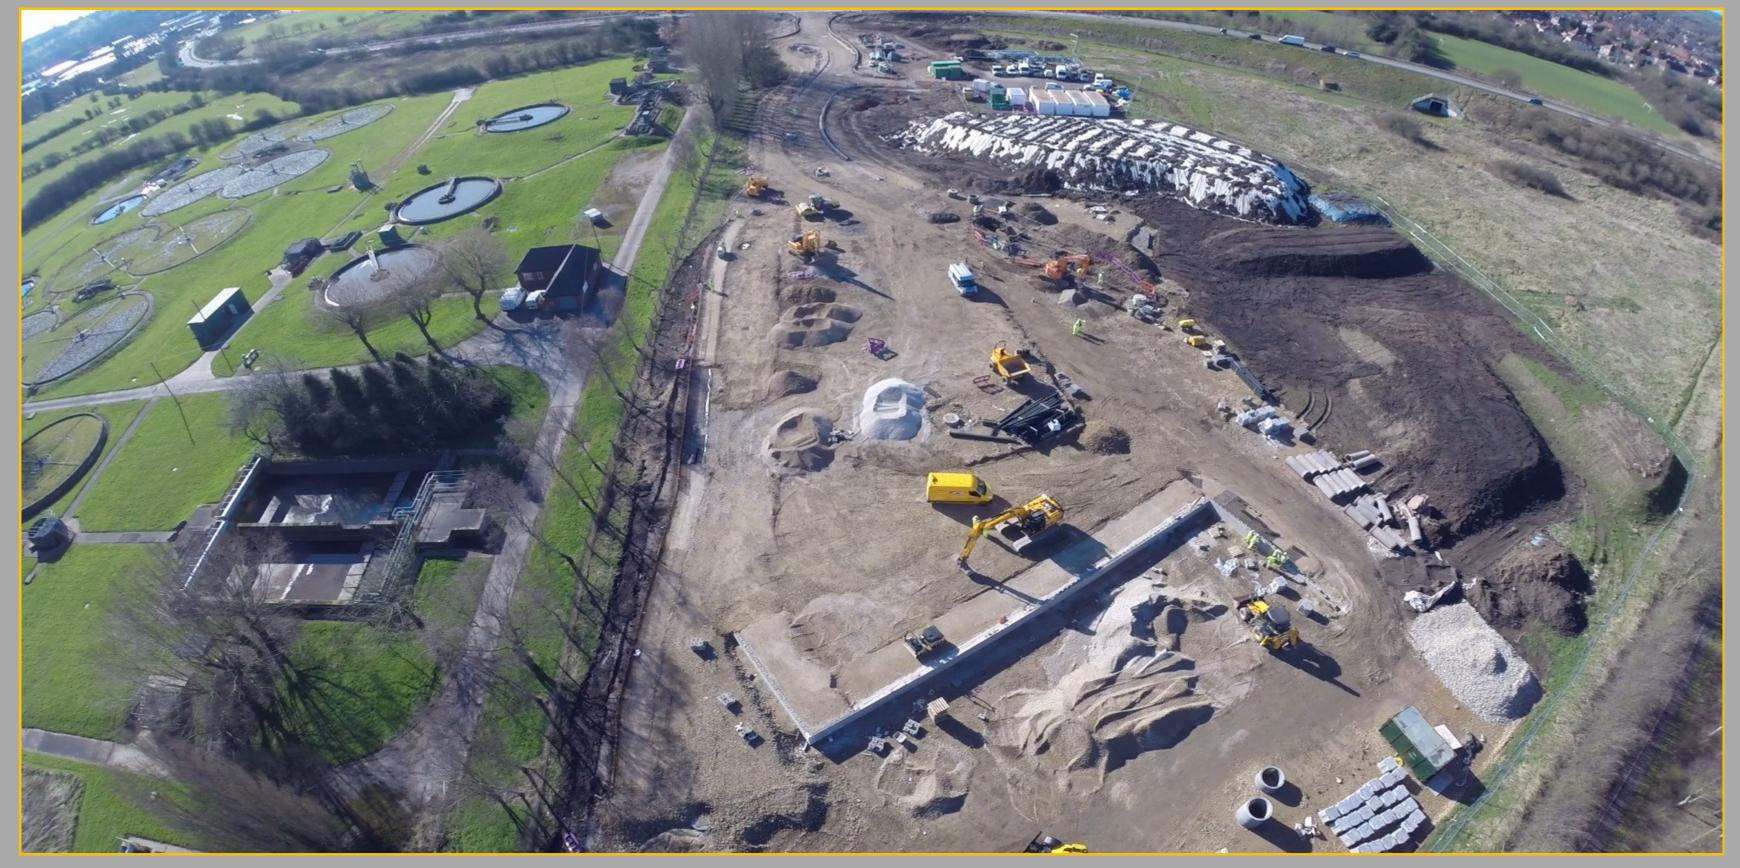
In order to provide stable ground and decrease voiding within the underlying material, high energy impact compaction (HEIC) was undertaken across key areas of the site.

Aerial view of the site during construction. Of the HWRC

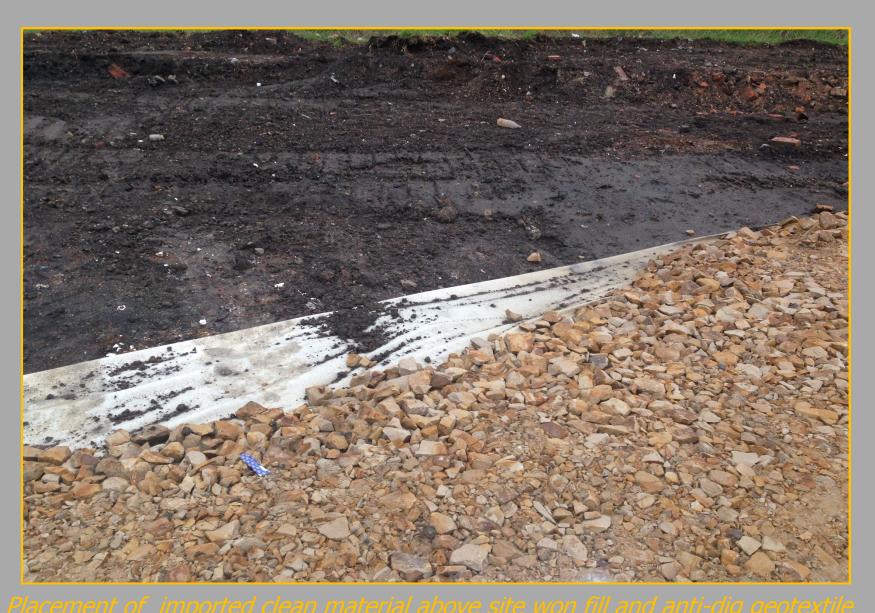
A proposed minimum 500mm of cover was agreed with the Local Planning Authority (LPA) to be sufficient to be protective of the measured concentrations, breaking any viable pathway to future users and avoid accidental disturbance of underlying wastes, particularly asbestos. In addition, the hardstanding further breaks pathways and the anti-dig geotextile membrane should discourage digging into the wastes in addition to greatly reducing natural soil mixing.

Verification consisted of nine trial pits in areas of soft landscaping to test samples of the topsoil and underlying imported material, to verify its suitability as clean cover material in-situ and verify that sufficient thickness of clean cover material is present across the site. Chemical testing confirmed suitability and each trial pit was excavated to a minimum of 0.65mbgl demonstrating that the thickness of clean cover exceeded the minimum thickness agreed with the LPA.
